Access audit report of St Katherine's Church of England Primary School

14th February 2022

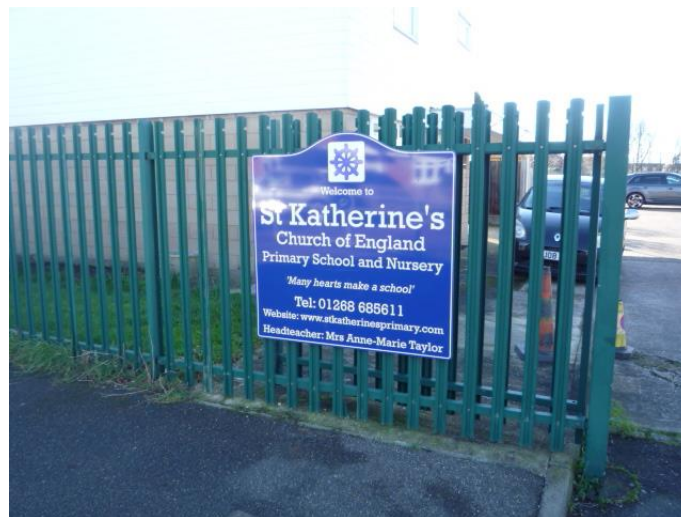
A

The exterior signage is suitably prominent (Image A). Signage is very important and, in this instance, could mean that a person with a hearing impairment could manage without having to ask directions, it could also help a person with limited sight more effectively.

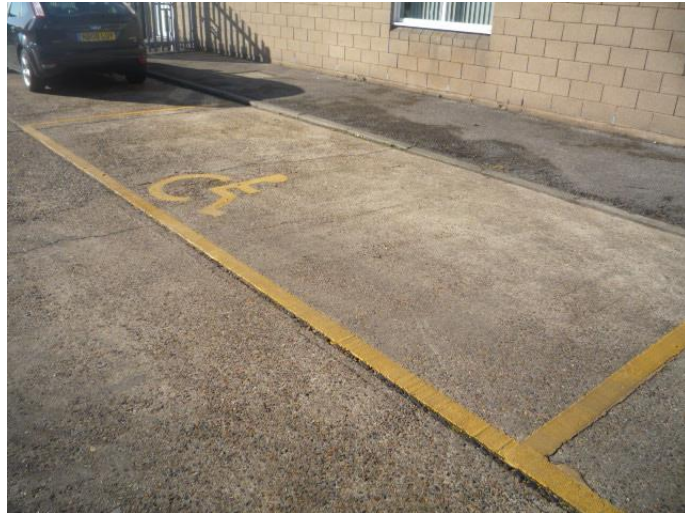
B

Site car parking is limited and predominately provided for staff use only, however 2no designated accessible parking bays are afforded (Image B).

Wheelchair access across and around the accessible parking bays is level and both are close to the school's principal entrance. The road paint is in excellent condition

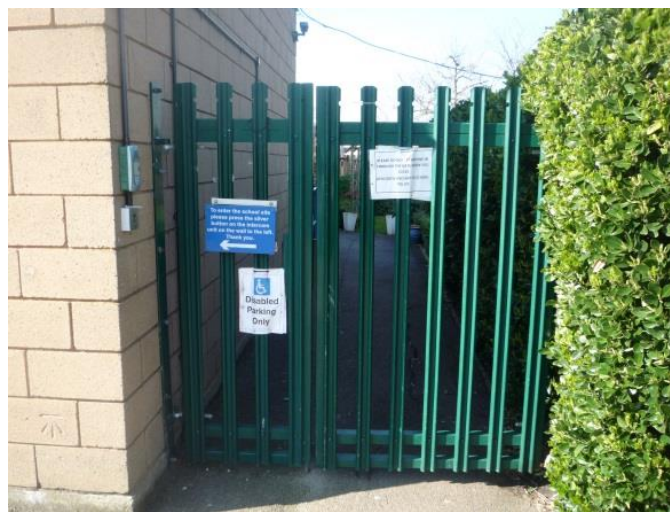
C

The security gate (Image C) at the head to the pedestrian route to the school's principal entrance incorporates an intercom direct to reception, set at 1450mm above finished floor level (affl); it is a little high for all users and should ideally be 1250mm affl. The gate provides ample through width of 1m thus allowing for easy wheelchair / mobility scooter access.

Re-position the entrance intercom to a more accessible height of 1250mm affl. (D)

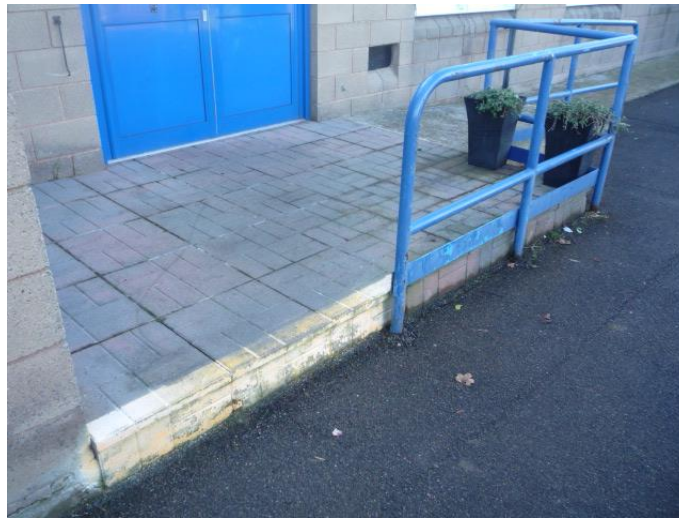
D

The principal entrance is approached by a single step or an adjacent ramp (Image D).

The step nosing has been highlighted previously however the paint has worn and required remedial work. The ramp is in good condition, it has the correct gradient of 1:24 for the overall change in level and it provides a slip-resistant surface.

Highlight (paint) the single step at the principal entrance **(B)**

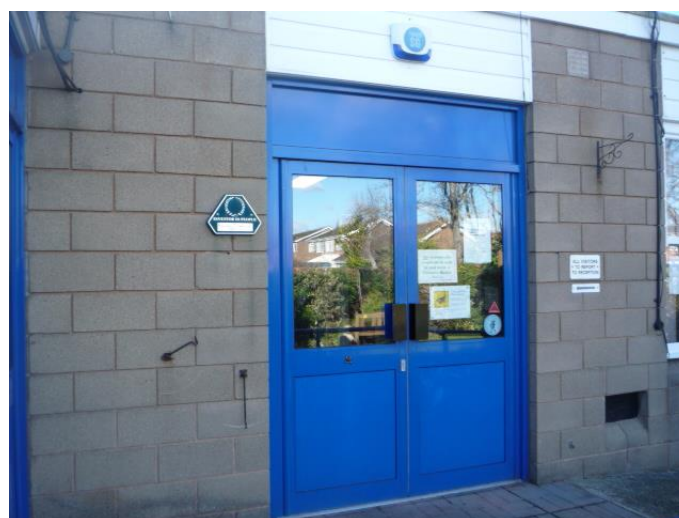
E

The entrance comprises of a 2-door set (Image E). Each door offers a sufficient clear width (760mm) to accommodate the vast majority of wheelchairs and mobility scooters however both doors can be opened if necessary – this is good practice. The threshold is reasonably level and the door handles finished in a contrasting finish – this is welcomed as they are visually apparent thus potentially benefitting people with a sight impairment.

At the time of survey there were a number of notices affixed to the R/H glazing panel, please be aware this is not good practice and should dissuaded

Remove any posters etc. currently on door vision panels. **(B)**

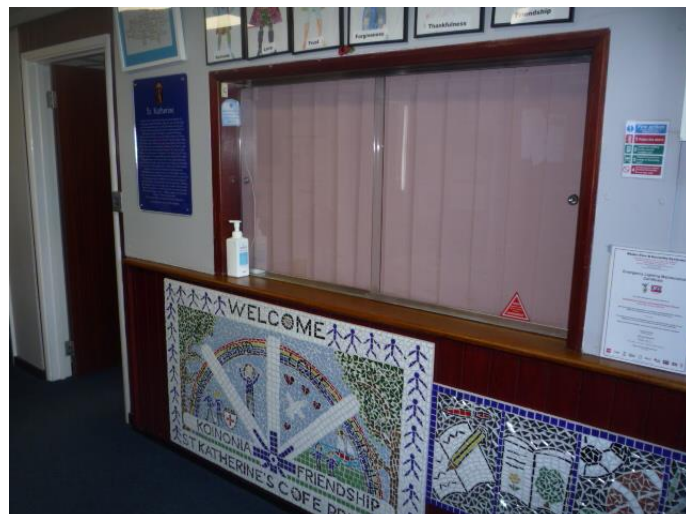
F

The weather mat immediately inside the entrance doors and the reception area carpet are very good. They each provide a short pile finish and are level and smooth so they are easy to traverse by a wheelchair user, they are also flush with the finished floor level thus limiting being a tripping hazard. The reception counter is high for some people at 950mm affl (Image F) but it is acknowledged there is a lower surface available for signing in etc. A hearing induction loop is not fitted.

Provide a portable hearing induction loop at reception. **(B)**

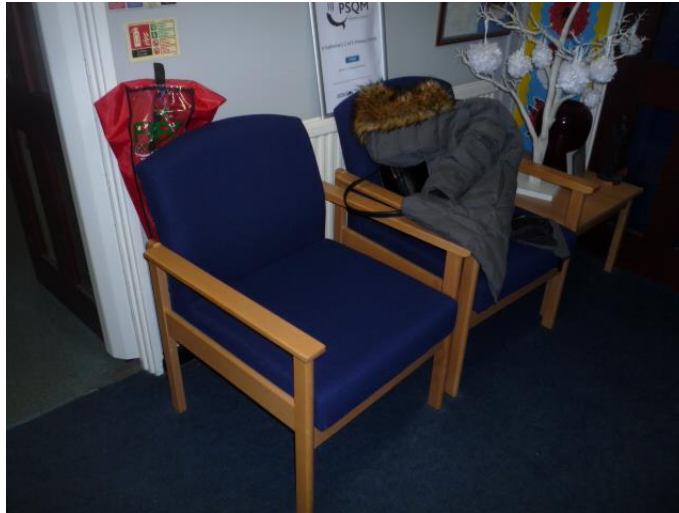
G

Occasional use seating is provided for use (Image G). Such provision shows good practice and the 2no seats are of excellent design fitted as they are with armrests.

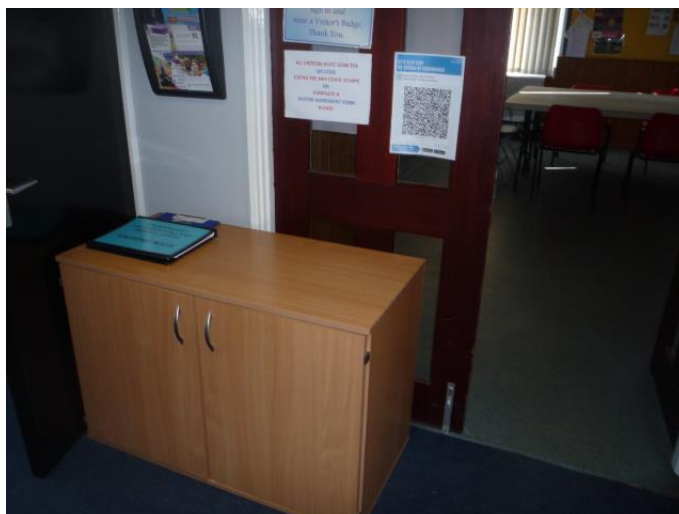
H

Entrance into the Parish Room is via 2no wooden doors each providing a 700mm through width. Ideally an internal door set such as these should provide a 750mm clear width however it is recognised that the second door could be easily opened if necessary, however at the time of survey a large cabinet was positioned in front of the L/H door (Image H).

Re-position cupboard in front of the Parish Room door **(A)**

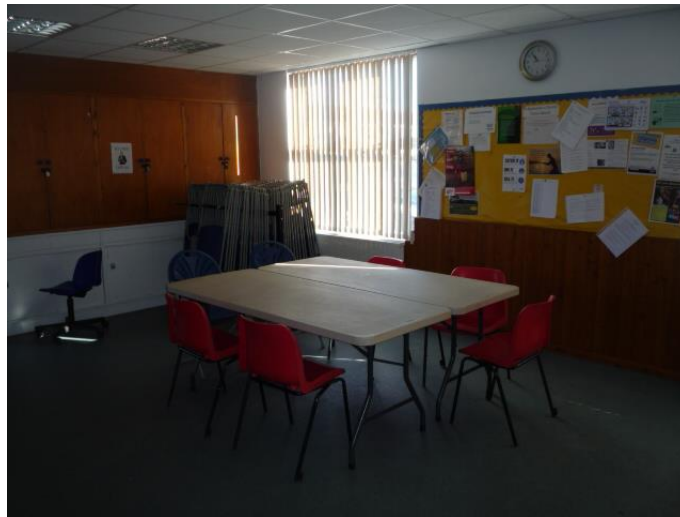
I

The room itself has very good levels of light with a mix of dual aspect natural light and fitted luminaires. Pleasingly the windows are fitted with blinds which help control the light level and the floor is laid to a hard and level finish. (Image I).

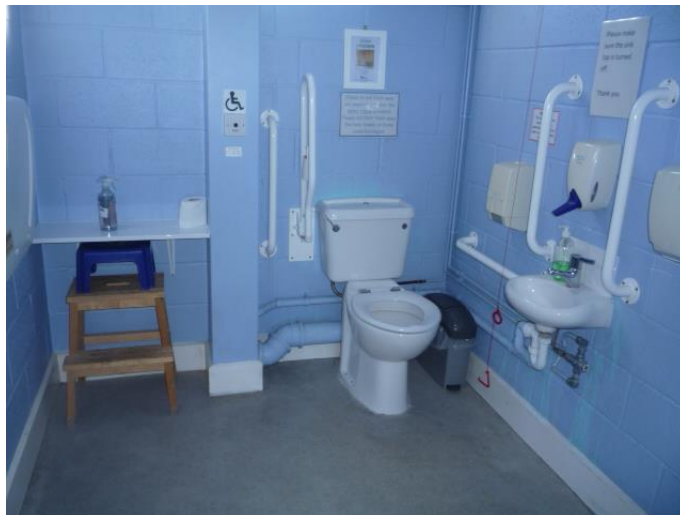
J

One of the 2no Accessible WCs on site is located in the Parish Room (Image J)

The WC offers an outward opening and excellent width door to accommodate all wheelchairs, level and slip-resistant flooring and very good tonal contrasting. **NOTE:** People with differing disabilities will use accessible facilities including those with visual impairments, hence why tonal contrasting is important. The lighting level is good with a single luminaire in situ together with a degree of natural light. The single lever type basin tap is of good design as are all the grab rails.

The internal dimensions of this accessible WC are satisfactory and the Alert Alarm (tested okay) has the correct length cord fitted. The cistern flush handle is on the (correct (Open) side and a single shelf is fitted.

It was noted at the time of survey that a number of the facility's fixtures and fittings require some remedial work to bring it up to 'good practice' design standards as well as those outlined in British Standards 8300 and Building Regulations Part M. Specific areas for improvement include:

- Height of mirror
- Lack of clothes hooks

The vanity mirror is currently positioned too high, ideally a mirror located either above the wash basin or on the opposite wall should be fitted to enable people to see themselves in a standing or seated position. Guidance suggests any mirror fitted should be at least 1000mm tall and have its bottom edge set at 600mm affl.

2no clothes hooks should be located at heights of 1400mm and 1050mm to allow use by ambulant disabled people and wheelchair users respectively.

Fit 2no clothes hooks in the Parish Room accessible WC **(B)**

Within the Parish Room accessible WC install a mirror that can be used by people standing or sitting **(B)**

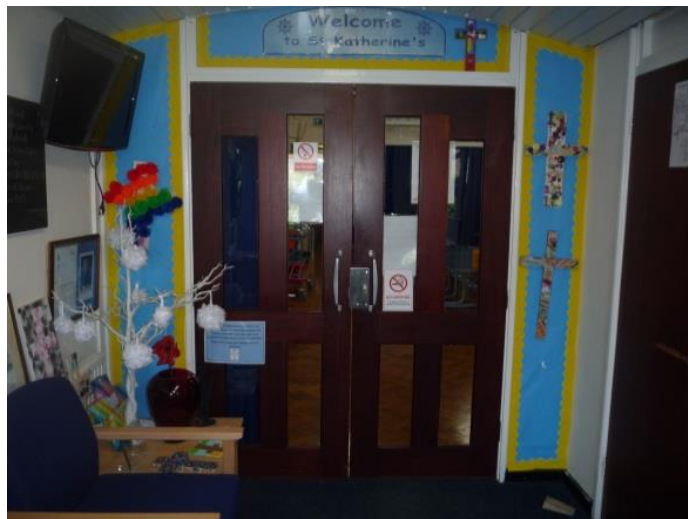
K

The Main Hall is a large space used for numerous activities and is accessed by a variety of double door sets all fitted with vision panels (Image K).

NOTE: Glazed vision panels are very useful as they ensure people approaching the door can be seen from either side; in that sense it's recommended the posters affixed to the areas of glass be re-located. Whilst the posters do not currently impair important areas of through vision it is poor practice.

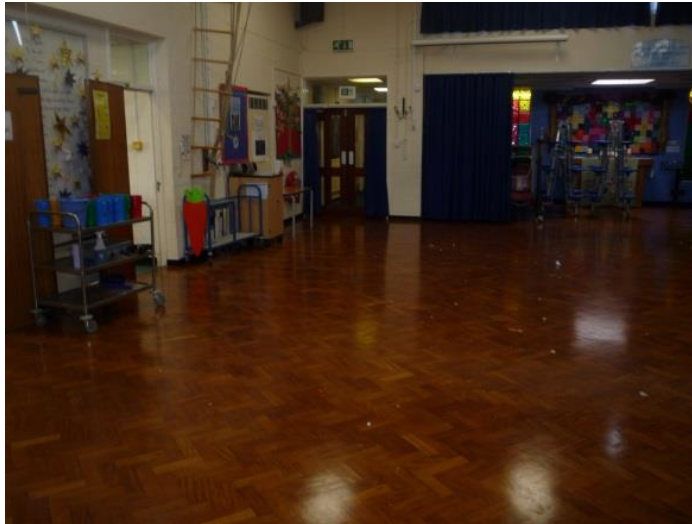
L

The Hall flooring is very good being both flat and even and it allows for easy wheelchair manoeuvre and circulation (Image L). The light levels within the Hall are good however a hearing induction loop is not fitted.

Install a hearing induction loop in the Main Hall. (D)

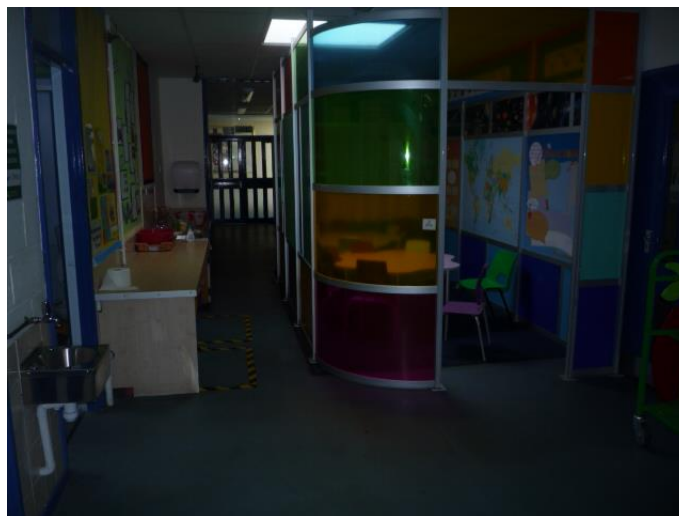
M

This area of the school affords excellent flooring which is firm and level. It offers very good levels of light with a mixture of fitted luminaires and some natural light – this is all good practice (Image M).

Although there is an abundance of furniture and clothing in the space, a suitable 750mm clear width is available through the area.

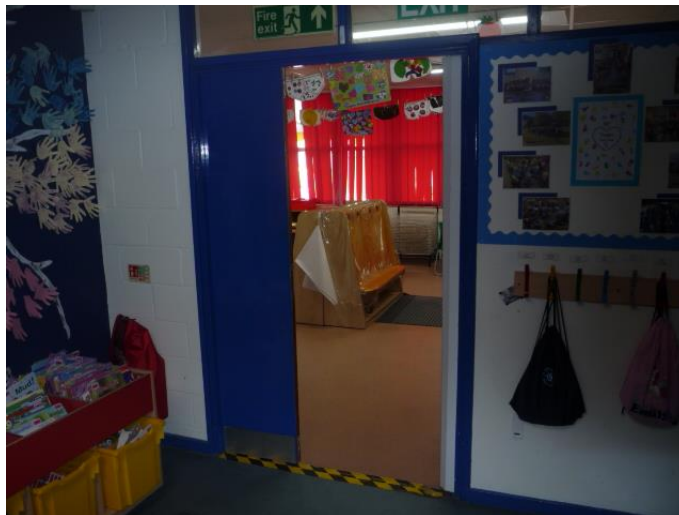
N

The reception classroom is accessed via a single door which provides an adequate clear width of 750mm, excellent through vision and very good door furniture – in terms of access this is all very good. (Image N).

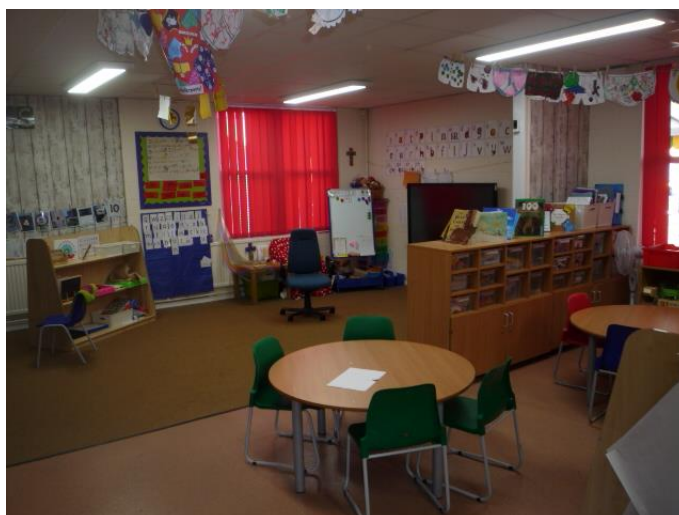
O

Good space is afforded for wheelchair circulation and very good levels of controllable light are provided by the fitted luminaires and window blinds (Image O)

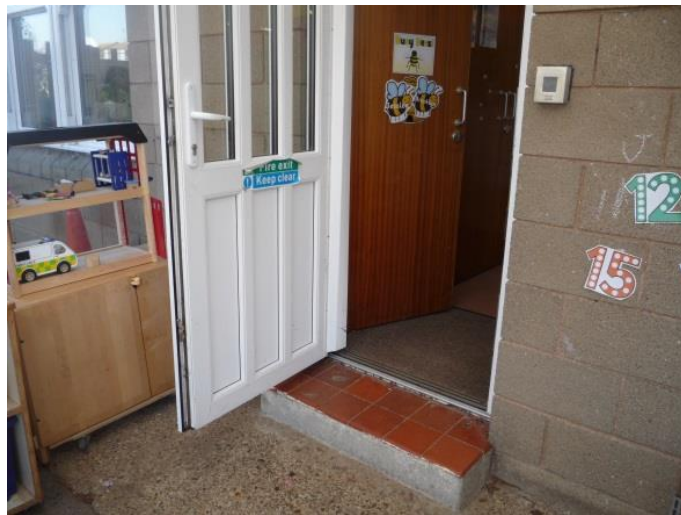
P

One concern is the single step at the fire exit (image P) which could make unassisted wheelchair egress difficult.

Consideration be given to ramping those fire exits currently stepped. An alternative could be to purchase some temporary ramps, often constructed from Aluminium they are light in weight and relatively low in cost (C)

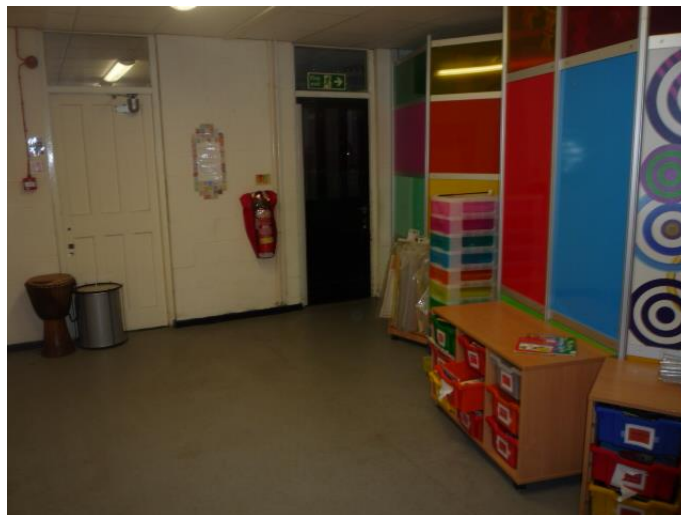
Q

Access into and within the Music Room is very good, again the doors are very good in terms of design, weight and furniture and the flooring is excellent (Image Q).

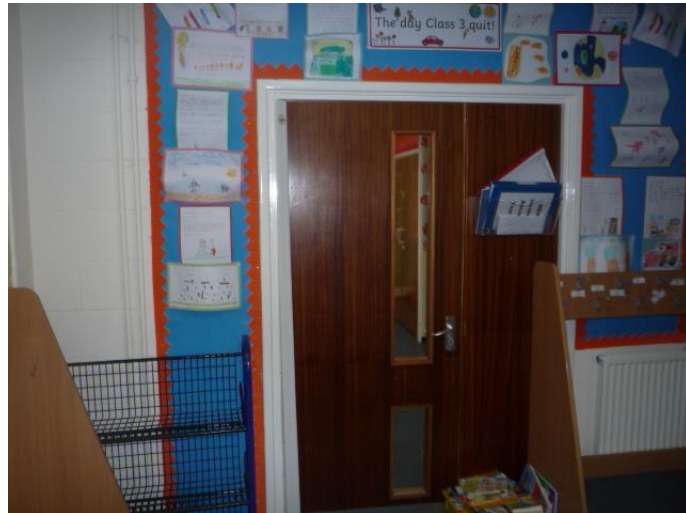
R

The classroom door affords adequate through width, is not too heavy and is fitted with excellent vision panels (Image R). All flooring is excellent and allows for easy wheelchair traversing and good lighting levels are provided by the numerous luminaires and windows.

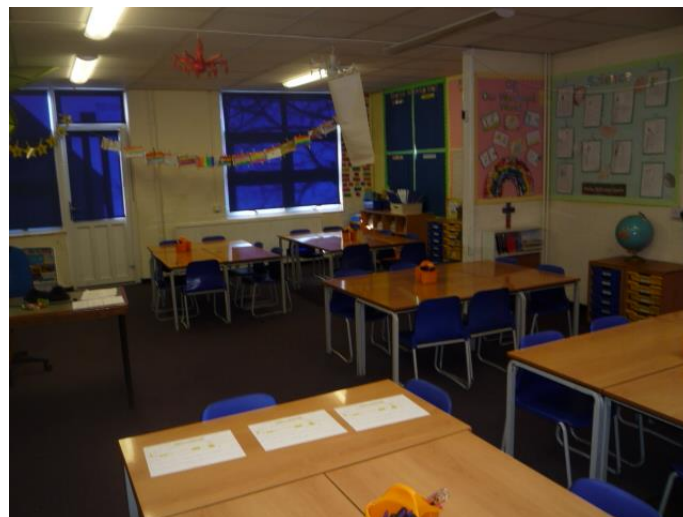
S

The chairs and desks are mostly easily moveable which enhances wheelchair circulation if necessary (Image S). In addition, the fact that the furniture is not fixed means that wheelchair users can use the tables (chair removed) the same as everyone else thus enhancing inclusion.

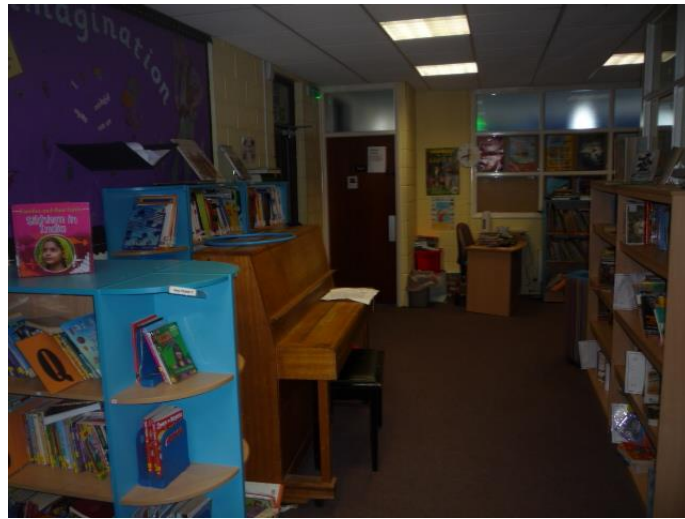
T

This area is fairly cluttered but still adequate widths are afforded for wheelchair users to circulate and manoeuvre. Light levels are good and the short pile carpet is good practice. **NOTE:** Please be aware that self-propelling

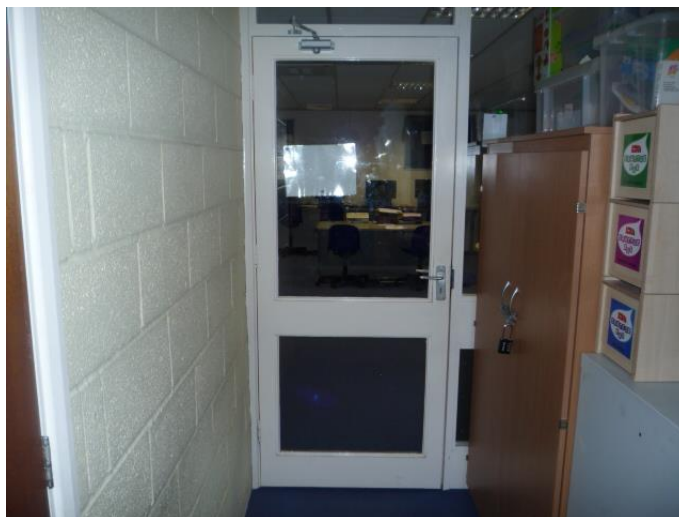
U

The ICT suite in terms of access is again very good. The door itself provides excellent through vision (Image U).). Just to reiterate, through vision (provided by glazed doors or vision panels) is extremely important particularly in schools where many of the building's users are short in stature as they ensure people approaching the door can be seen from either side.

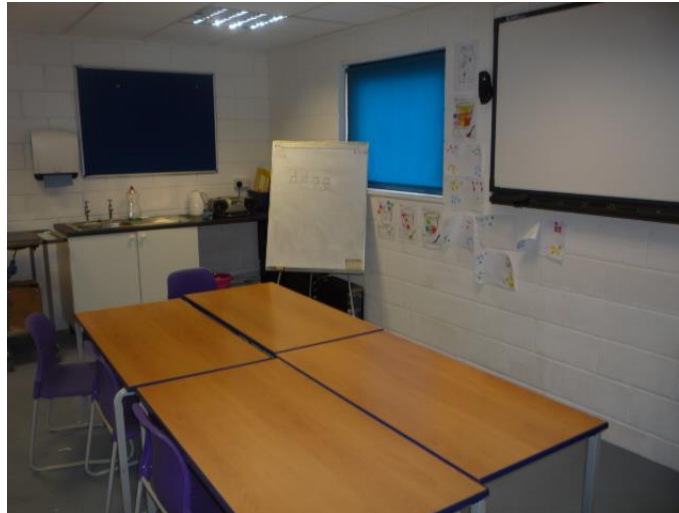
V

The Tech room (Image V) is reasonably accessible given it's a relatively small area and helped by the fact the furniture can be re-positioned as necessary.

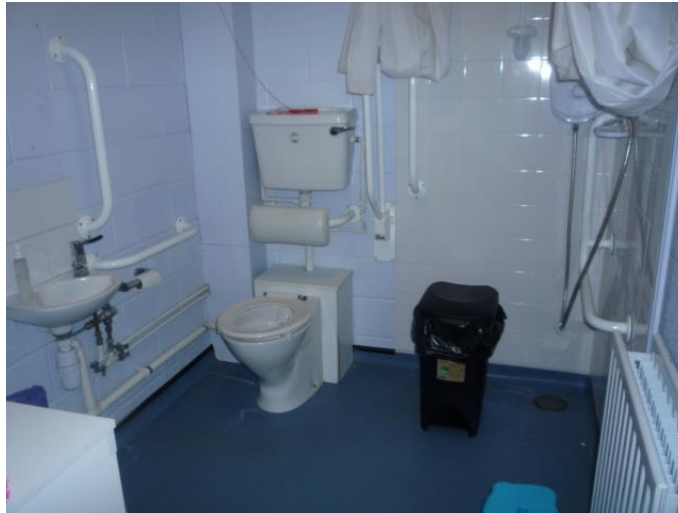
W

This space doubles as a Wet Room and the facilities within are all accessible (Image W).

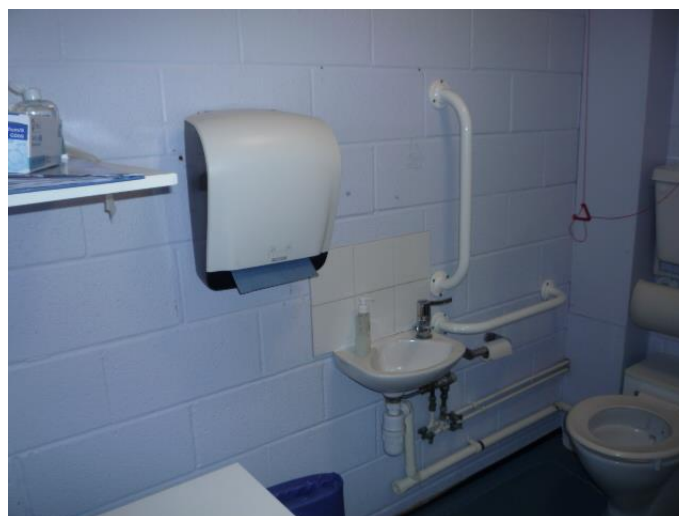
X

The cistern flush is well designed and fitted to the correct side and clothes hooks are provided. All the grab handles are good, a small shelf is fitted and the Alert Alarm worked when tested, the basin tap is correctly positioned nearest to the WC – all very good practice. (Image X)

The roller-towel is poorly positioned in the room being too far from the WC.

Install a paper towel dispenser for drying hands so that it's adjacent to the pan in the accessible WC (nr ICT) **(B)**

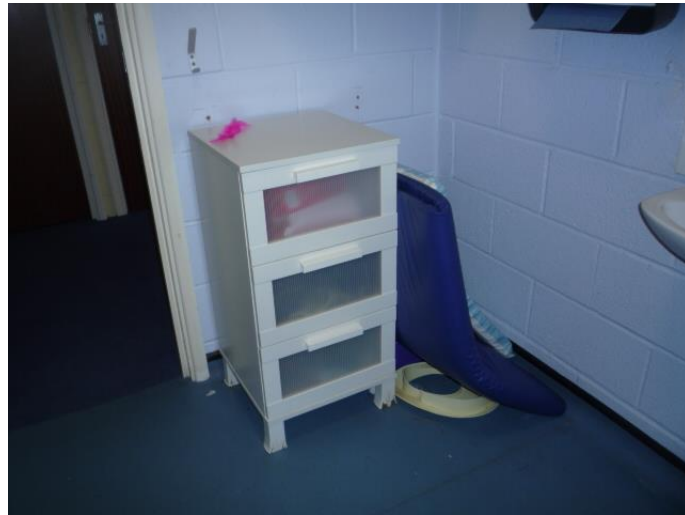
Y

Given the facility must allow for suitable wheelchair circulation it is a recommendation that the small set of drawers (Image Y) be re-positioned further into the corner of the space together with the waste bin currently adjacent to the WC.

Within the accessible WC (nr ICT), reposition the set of drawers and waste bin into the corner of the space **(A)**

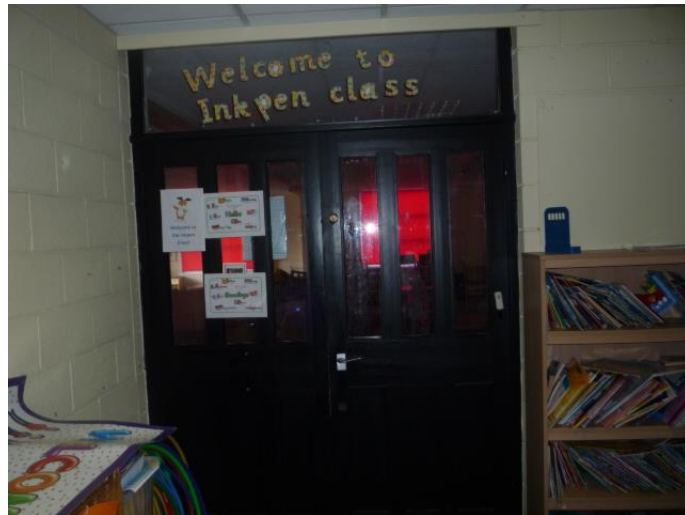
Z

Unfortunately, the entrance door is not fitted with lower vision panels whilst those above are again partially obscured by notices etc. (Image Z).

Fit vision panels in the lower sections of the Nursery door (D)

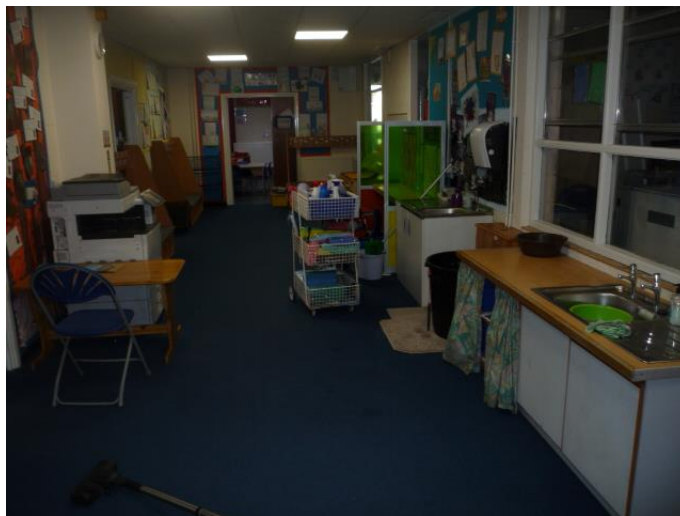
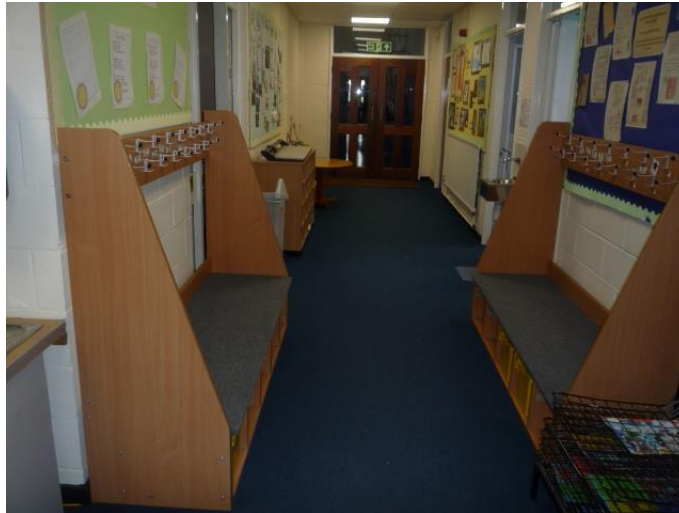
Another area where there is normally an abundance of clothes and items of furniture etc. but overall, the space can still be deemed as 'accessible' helped by the short pile carpet. However, it's important that areas like this are managed to ensure a clear passageway is always available. (Images AA & BB).

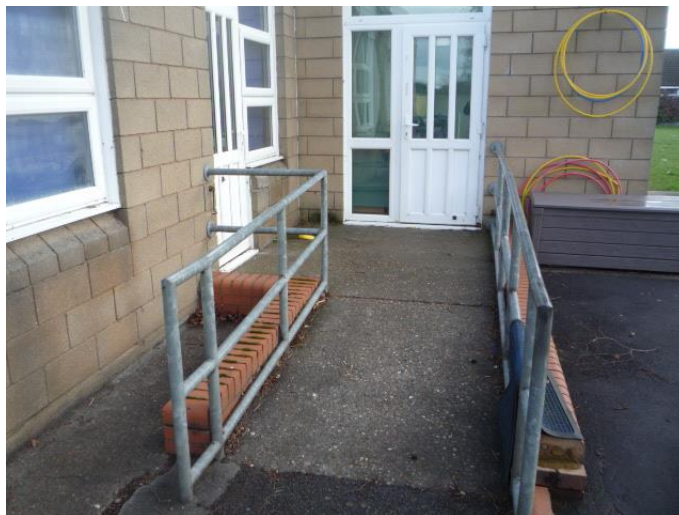
CC

All the external areas are generally good with very few steps in place to hinder wheelchair access whilst some classroom exits are ramped which is very good practice (Image CC). Additionally, the ramps are well constructed in that they have the correct gradients, handrails and upstands and all provide a suitably slip-resistant surface – this is all excellent.

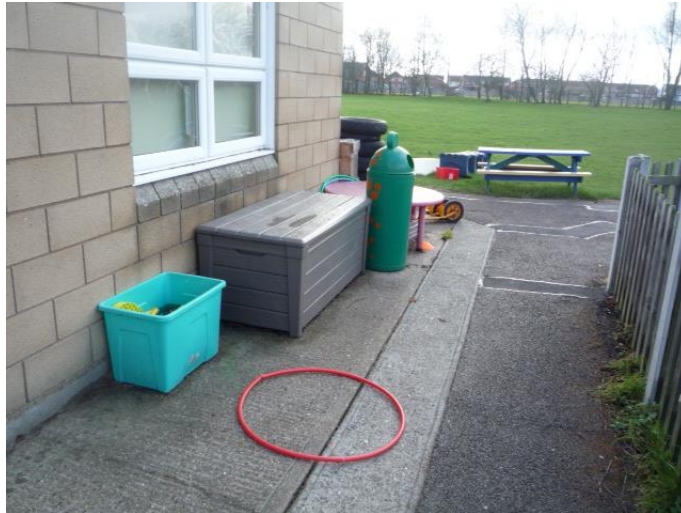
Some areas of the outside space could be improved however. The storage boxes (Images DD & EE) should be re-positioned and other equipment tidied thus ensuring the walkways remain fully accessible.

Ensure all external walkways remain clutter free **(A)**

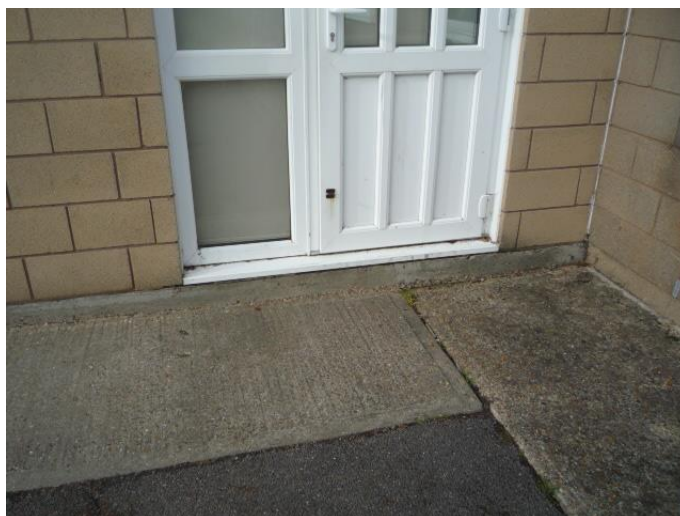
Some of the fire exits at the school have single steps down to the outside areas (Image FF as an example). These level changes could be problematic to some wheelchair and Mobility Scooter users and it is recommended remedial works be considered in an effort to make the thresholds more level or at least ramped.
